# HIROSHIMA, JAPAN - BAMBOO BARRIER™ RHIZOME PRUNING PROJECT

PRODUCT: WB 36

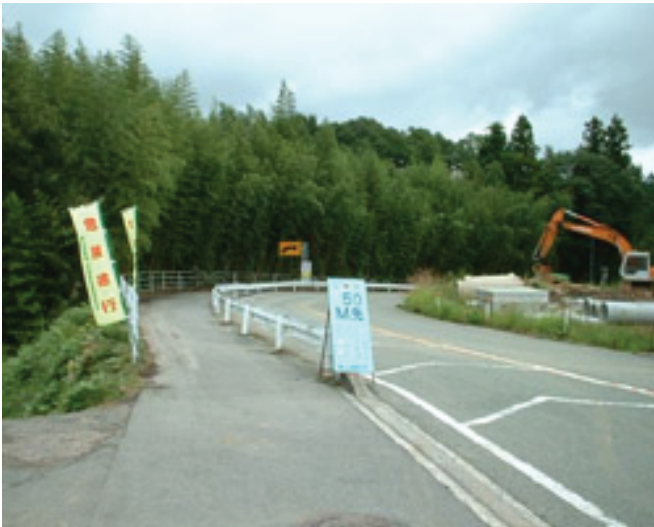
Rhizomes from the adjacent bamboo forest were causing this multi-use path in Hiroshima, Japan to buckle and heave. Tired of the on-going problem and costly repairs the local authorities sought a more permanent solution. After removal of the damaged asphalt a trench was dug and the rhizomes pruned. DeepRoot WB 36 was then installed to block future surface rhizome growth.

Damaged Multi-Use path

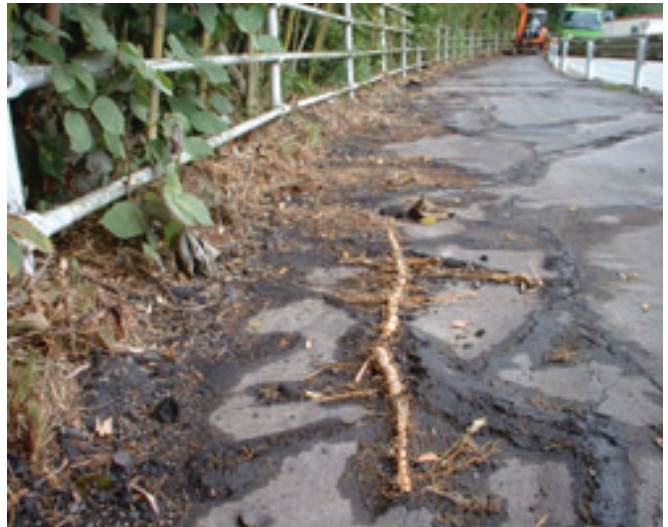
Detail of path

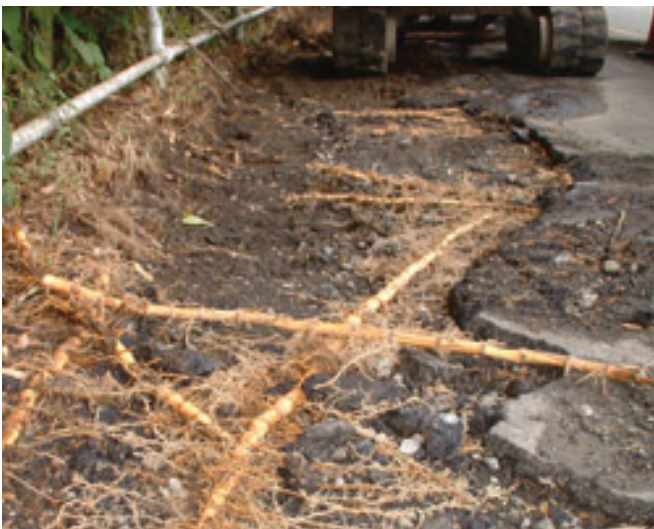
Surface rhizomes

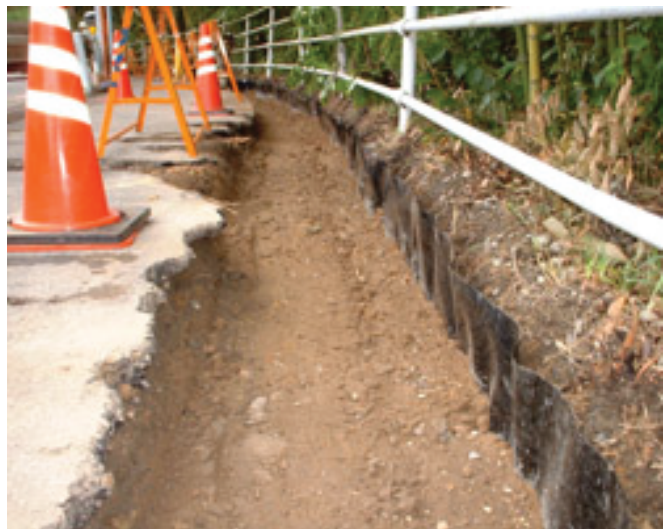
BambooBarrier™ installed
