# **Growth Rates and Performance of Trees in Silva Cells**

*Case study of nearly 400 trees at  
10 locations, after 2 to 6 years*

James Urban, FASLA, and Leda Marritz

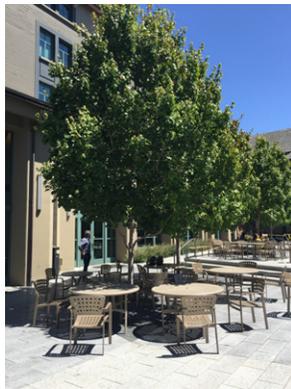
A tree rated "1" (Excellent) at Haas School of Business in Berkeley, CA.

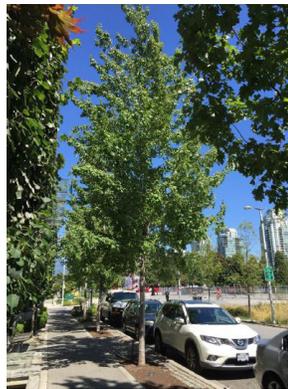
A tree rated "2" ("Good") at South East False Creek in Vancouver, BC.
