WATER BARRIER - McCARTHY CENTER, MILPITAS, CA.

PRODUCT: WB 36

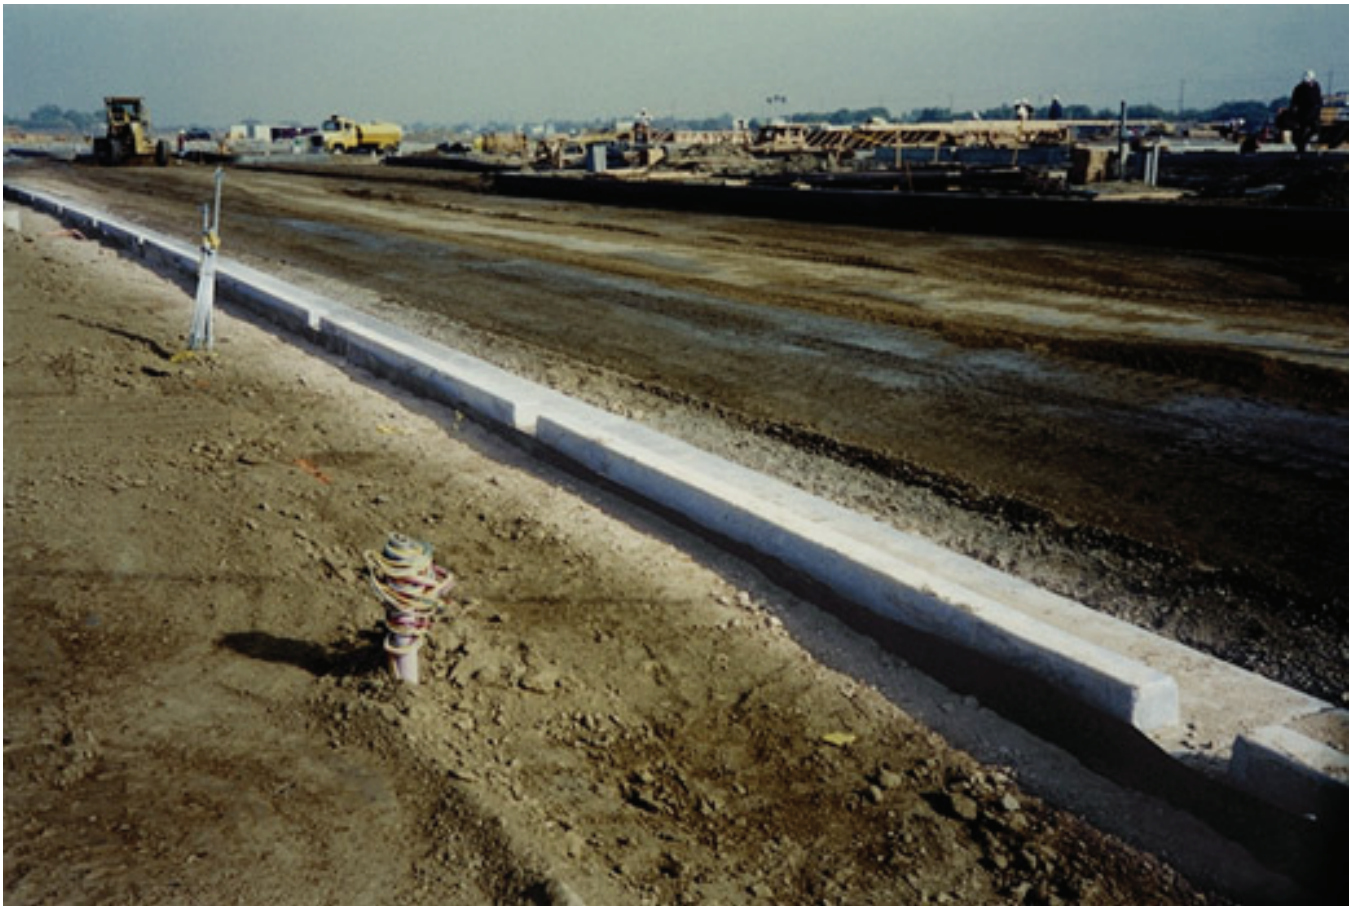
Installation - 1999

A common problem for engineers and architects is the issue of water movement from an irrigated planting zone to the substructure of a hardscape area. Unchecked water flows can erode the sub-base, leading to potholes and surface degradation. At the McCarthy Center, a large corporate office park in Silicon Valley, the solution was lining the curbing with 36" depth Water Barrier to prevent underground water migration from damaging the hardscape.
